Jeep Grand Cherokee

Zamena ležaja zadnjeg točka

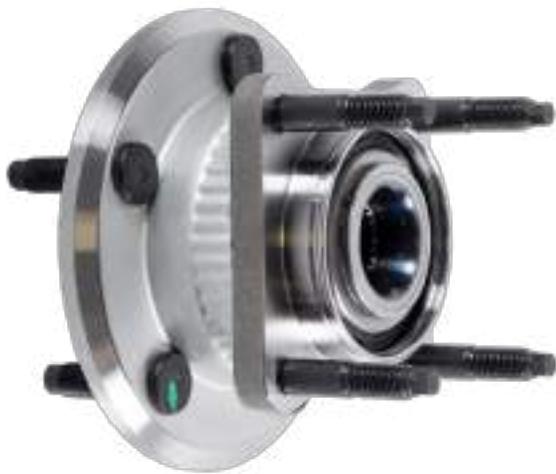
Figure 1

The preassembled febi wheel bearing kit 172491 was chosen for this repair. This comes complete with wheel and axle studs and the bearing is preloaded and greased ready for assembly to the vehicle. (Fig. 1)

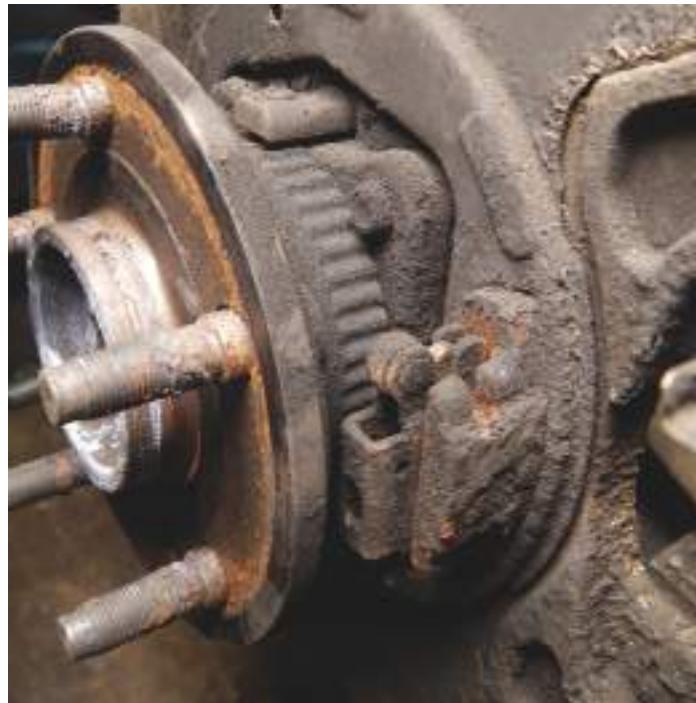
Figure 2

Sajla poluga za aktiviranje parking kočnice je raskačena i proverena, u slučaju da postoji korozije i lufa prilikom rada. (Fig. 2)

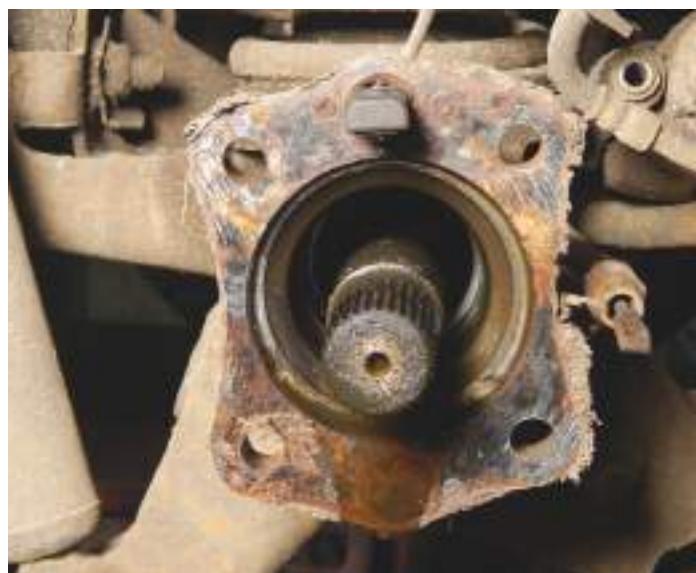
Figure 3

Sa skinutim svim delovima kočnog sistema, četiri šrafa koja su držala sklop ležaja su odvrnuta. Skinut je sklop ledaja, ostavljajući ABS senzor u mestu. Međutim, nosač kočne papuče i mehanizma doboš kočnice je ostao pričvršćen. U nekim slučajevima postoji mogućnost da poluvratilo ostane pričvršćeno, što onda zahteva izvlačenje vratila i ponovno vraćanja i spajanje sa diferencijalom unutar osovine.

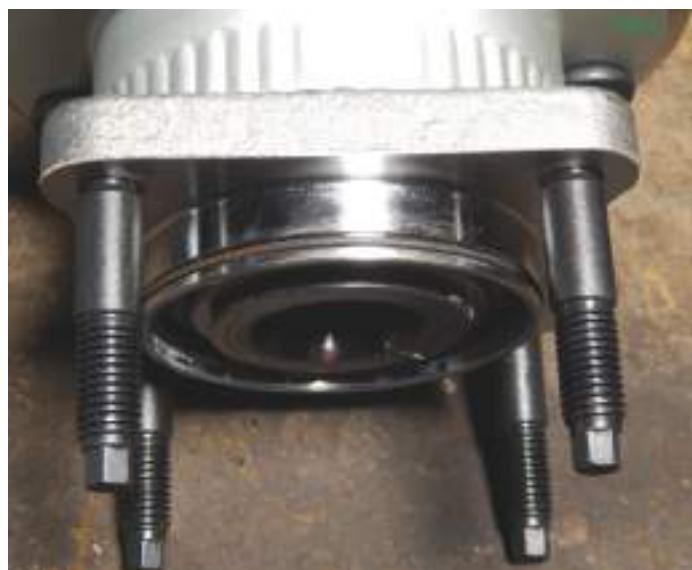
Figure 4

Pošto su svi delovi bili spremni za ponovno montiranje, postavljene su na novi sklop ležaja zajedno sa „O“ ringom pozicioniranim u kanalu koji se nalazi na samom ležaju.

Napomena: Ukoliko se „O“ ring ne postavi pravilno, to može dovesti do curenja ulja iz osovine, što utiče na obloge kočnih papuča.

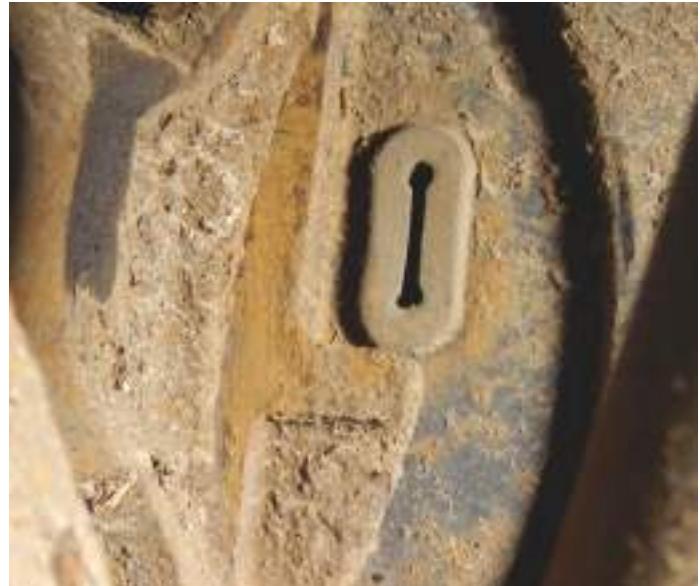
Figure 5

Napomena: Ukoliko je potrebno neko podešavanje, ukloniti vodicu iz otvora sa zadnje ploče. (slika 5) Nakon toga, odvrnuti navrtku za podešavanje sajle parking kočnice dok ne postane labava.

Odgovarajući alat za podešavanje treba ubaciti kroz otvor na zadnjoj ploči kako bi alat preko ozubljenja podešavao točkić. Okretati točkić dok se ne oseti blago kočenje prilikom okretanja točka.

Pritisnuti i zadržati polugu za podešavanje od točkića za podešavanje sa tankim šrafcigerom. Pomeriti točkić dok ne prestanu papuče da dodiruju metalni element.
